Manhole Inspection Summary

Manhole # S35WW1021MH

Location Address: **316 TUNBRIDGE RD**

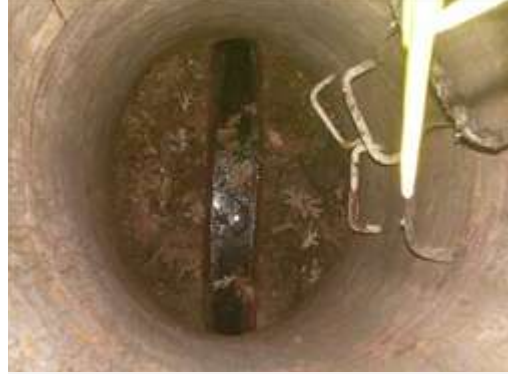
Top View

Corroded steps. Bench and Channel debris.

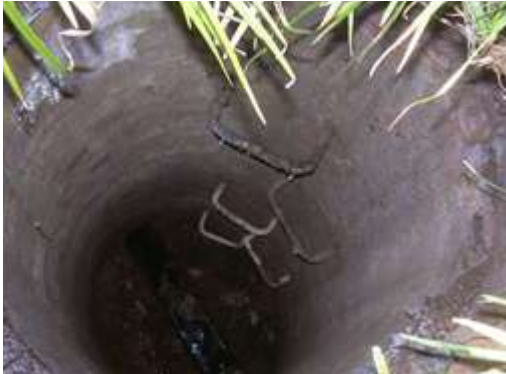
Defect

Corroded steps. Adjustment and Barrel infiltration.

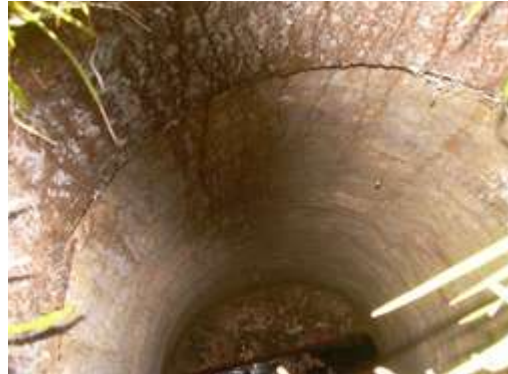
Defect

Frame leaks. Adjustment and Barrel infiltration - other side.

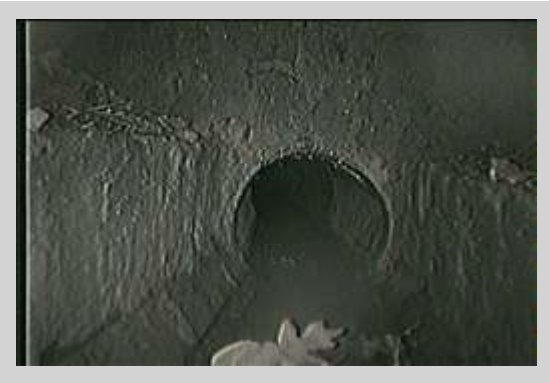
8 in. Circular Gravity Sewer Pipe Out @ 12 O'Clock

Deposits: ☐ None ☒ **Mud** ☐ Sludge ☒ **Debris** ☐ Grease

Silt Depth: **0.5** (in.) Deposits Extent: **Light**

Infiltration: **Evidence** Pipe Seal Cond: **Cracked**

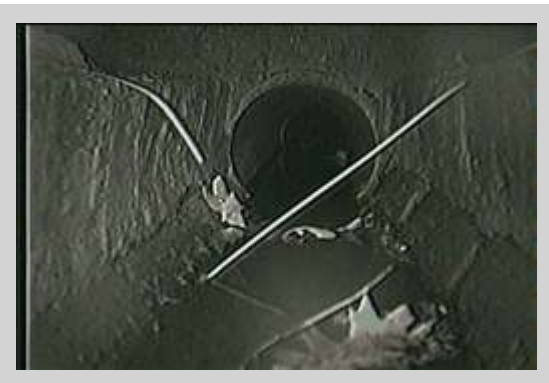
8 in. Circular Gravity Sewer Pipe In @ 6 O'Clock

Channel deterioration.

Deposits: ☐ None ☒ **Mud** ☐ Sludge ☒ **Debris** ☐ Grease

Silt Depth: **0.5** (in.) Deposits Extent: **Light**

Infiltration: **Evidence** Pipe Seal Cond: **Cracked**
